Research Report
515

**ACOUSTIC EMISSION MONITORING
OF WELDMENTS**

ACOUSTIC EMISSION MONITORING OF WELDMENTS

ABSTRACT

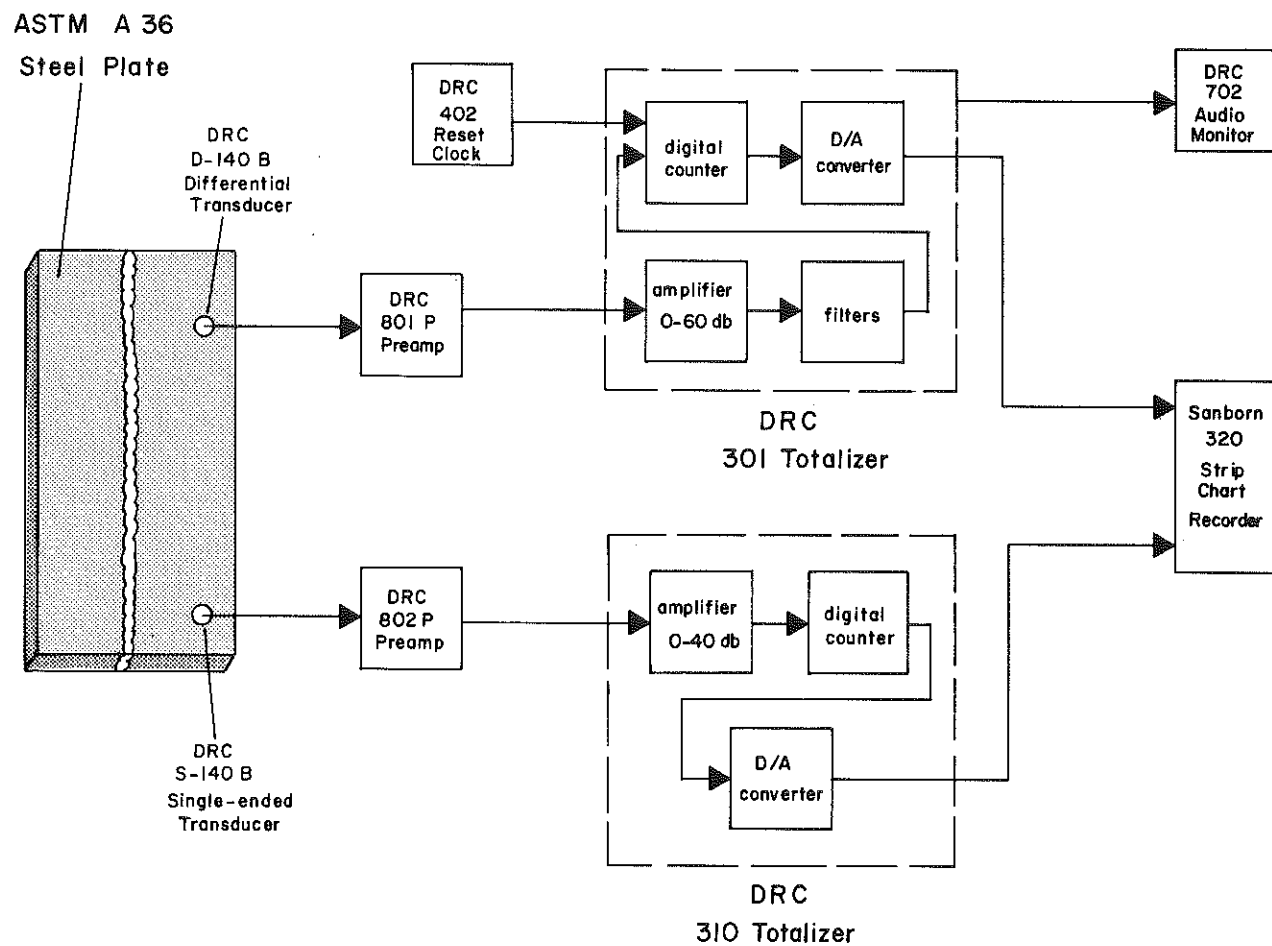
Figure 1. Acoustic Emission Detection System Used in Weld Tests.

The test device used in this study was a Dunegan Model 3000 acoustic emission monitor. The AE monitor, as shown in Figure 1, consists of a variety of modular AE signal processing components, preamplifiers, and receivers (transducers). Transducers were attached to a weldment with magnets, and a polyester resin, Dow Chemical DV-9, was used between the transducer and the weldment to achieve good acoustical coupling. When stimulated by stress waves, transducers emitted low-voltage electrical signals proportional to the magnitude and intensity of the impressed stress waves.

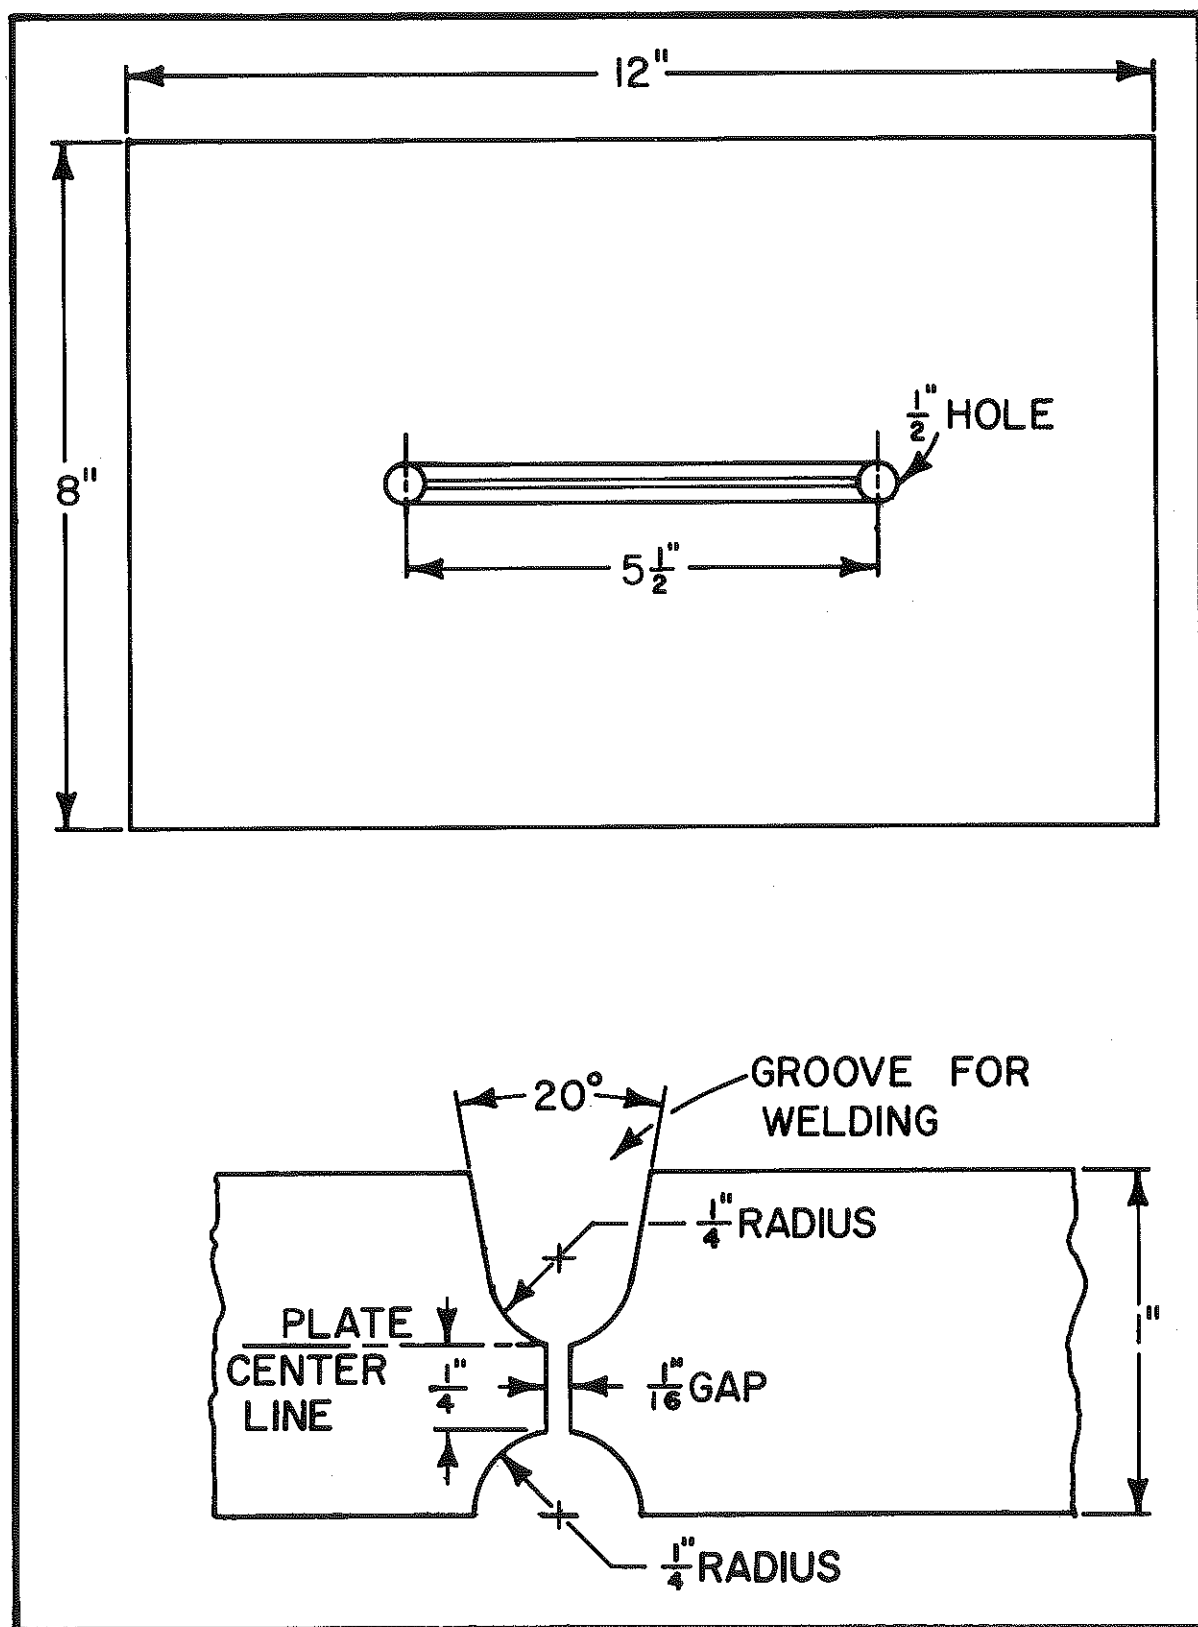
Figure 2. Lehigh Restraint Specimen.

Two types of high-restraint weldments were selected for the third series of tests. The A 588 steel was used in the Lehigh restraint specimen, shown in Figure 2, with full restraint. A single electrode pass was made in the slot with the 20° bevel. The A 514 steel was employed in the cruciform test shown in Figure 3. Four single-pass fillet welds were deposited sequentially in a counter-clockwise order.

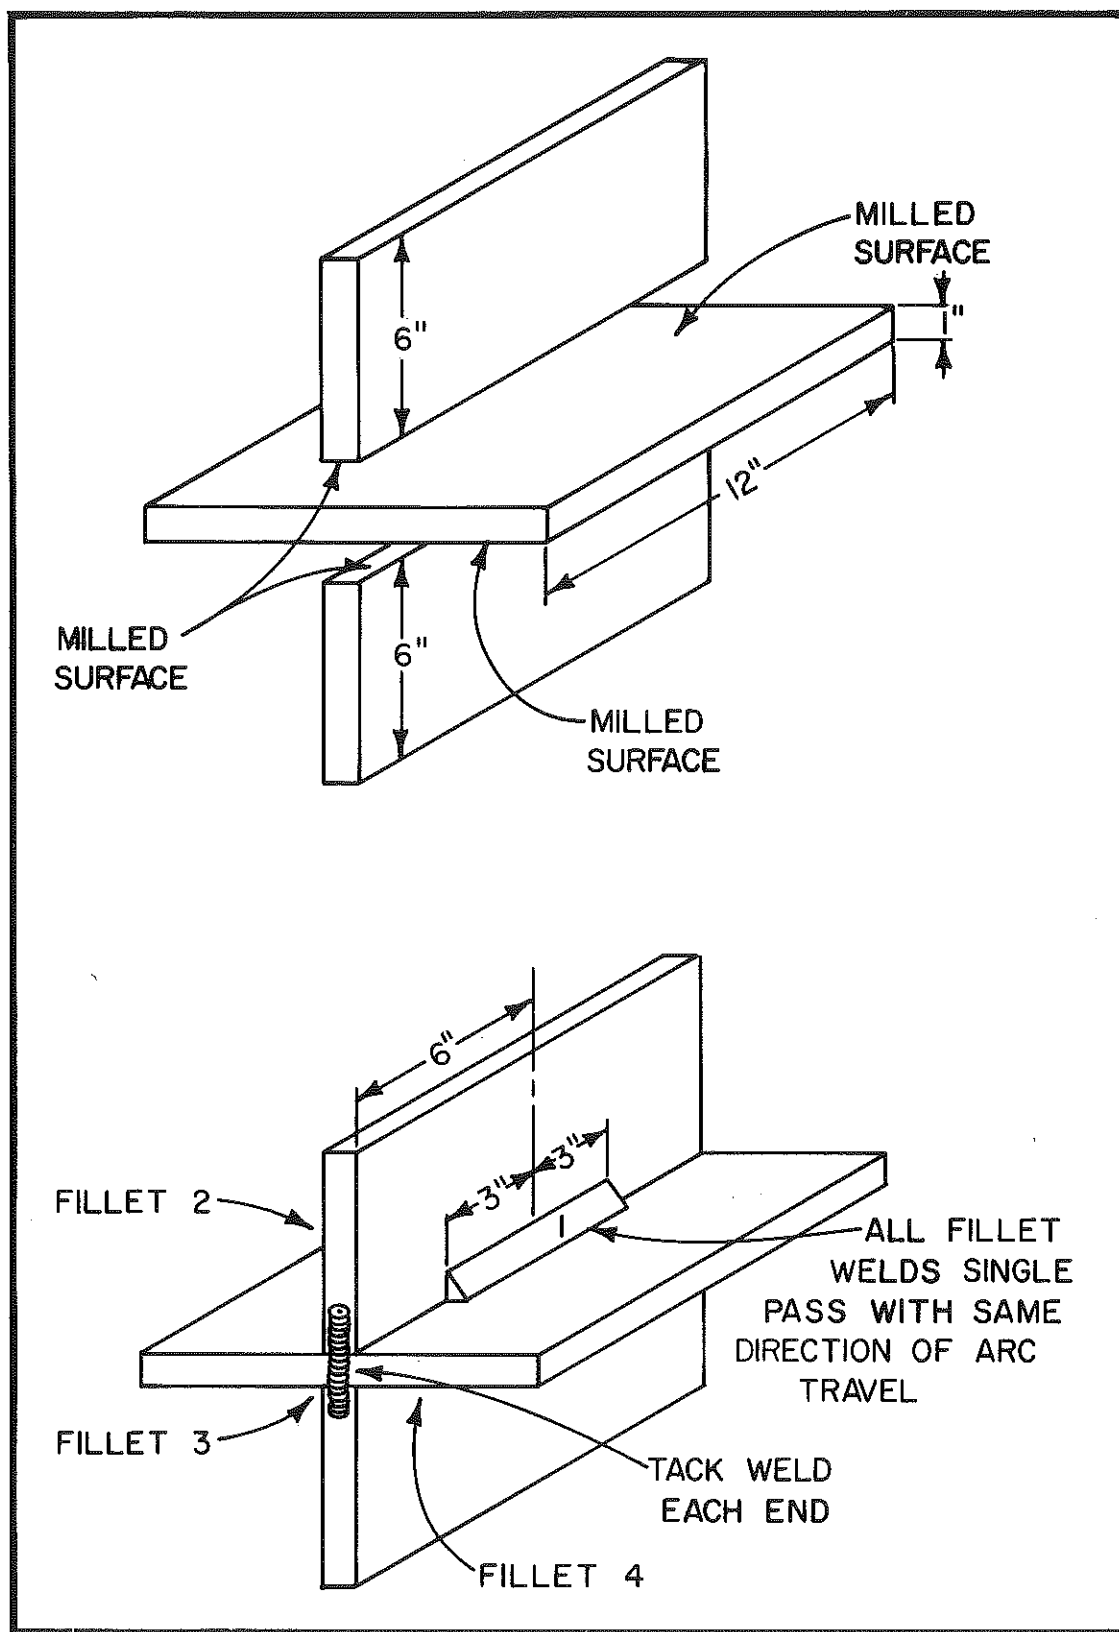
Figure 3. Cruciform Restraint Specimen.

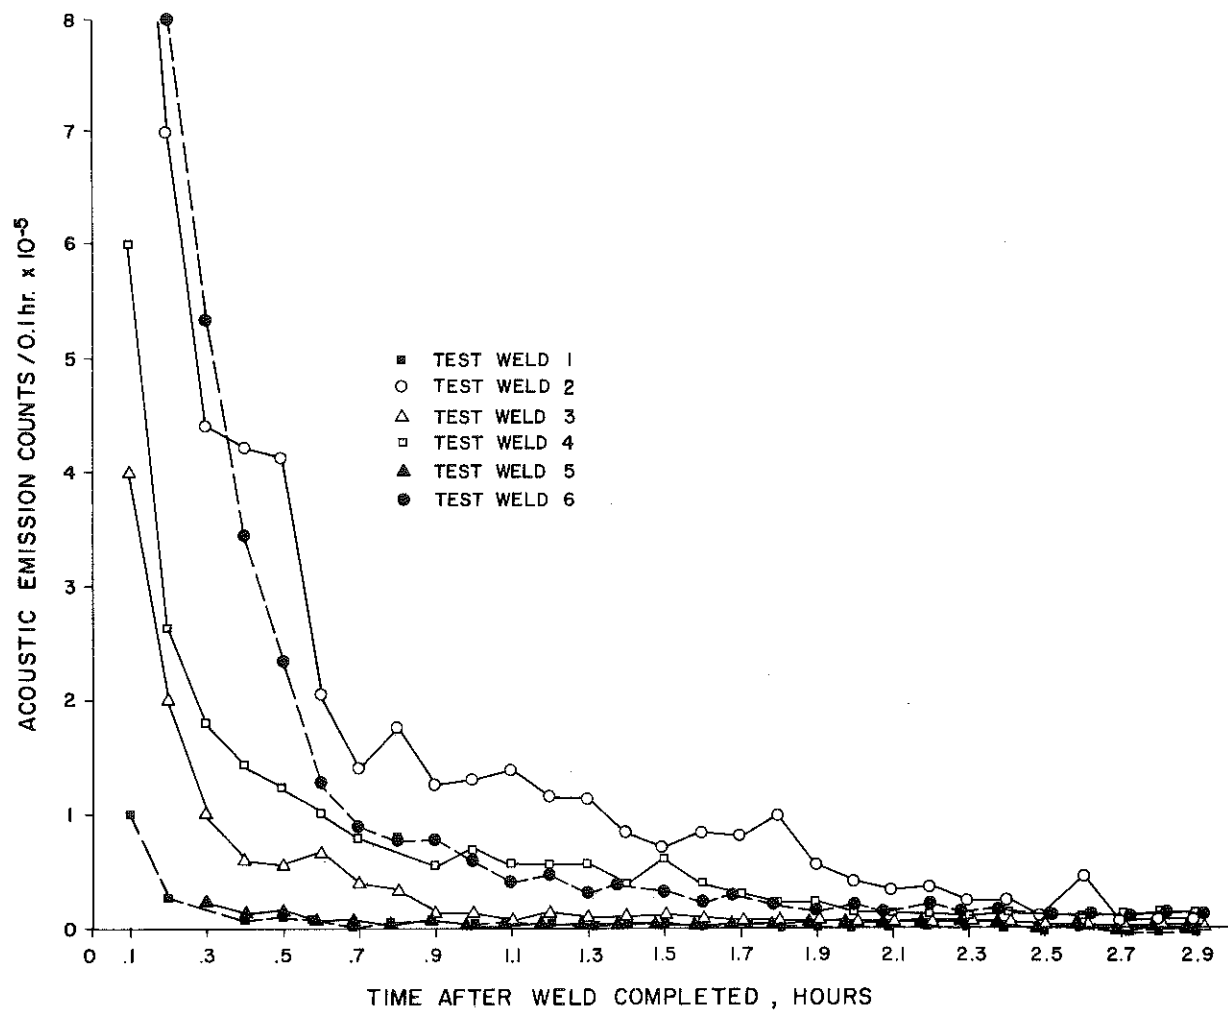
Figure 4. 'In-cooling' AE Rates vs Cooling Time for Test Welds 1 through 6.

Figure 4 shows the 'in-cooling' AE rate monitoring of the weld tests. This type of testing provides a good indication of defects and their relative activity. Defective welds containing slag inclusions (Welds 2, 4, and 6) showed higher AE rates than acceptable welds (Welds 1 and 3) for periods up to 3 hours after welding was completed. Slag inclusions were typified by continuous AE activity which was very intense for a 2-hour period after the weld was completed.

AE activity in Test Weld 5 differed from the others. Unfortunately, the recording device failed to function properly during the initial part of the 'in-cooling' process, and those data were lost. Acoustic emissions occurred in random bursts characteristic of crack propagation and(or) possibly martensite transformation (7).

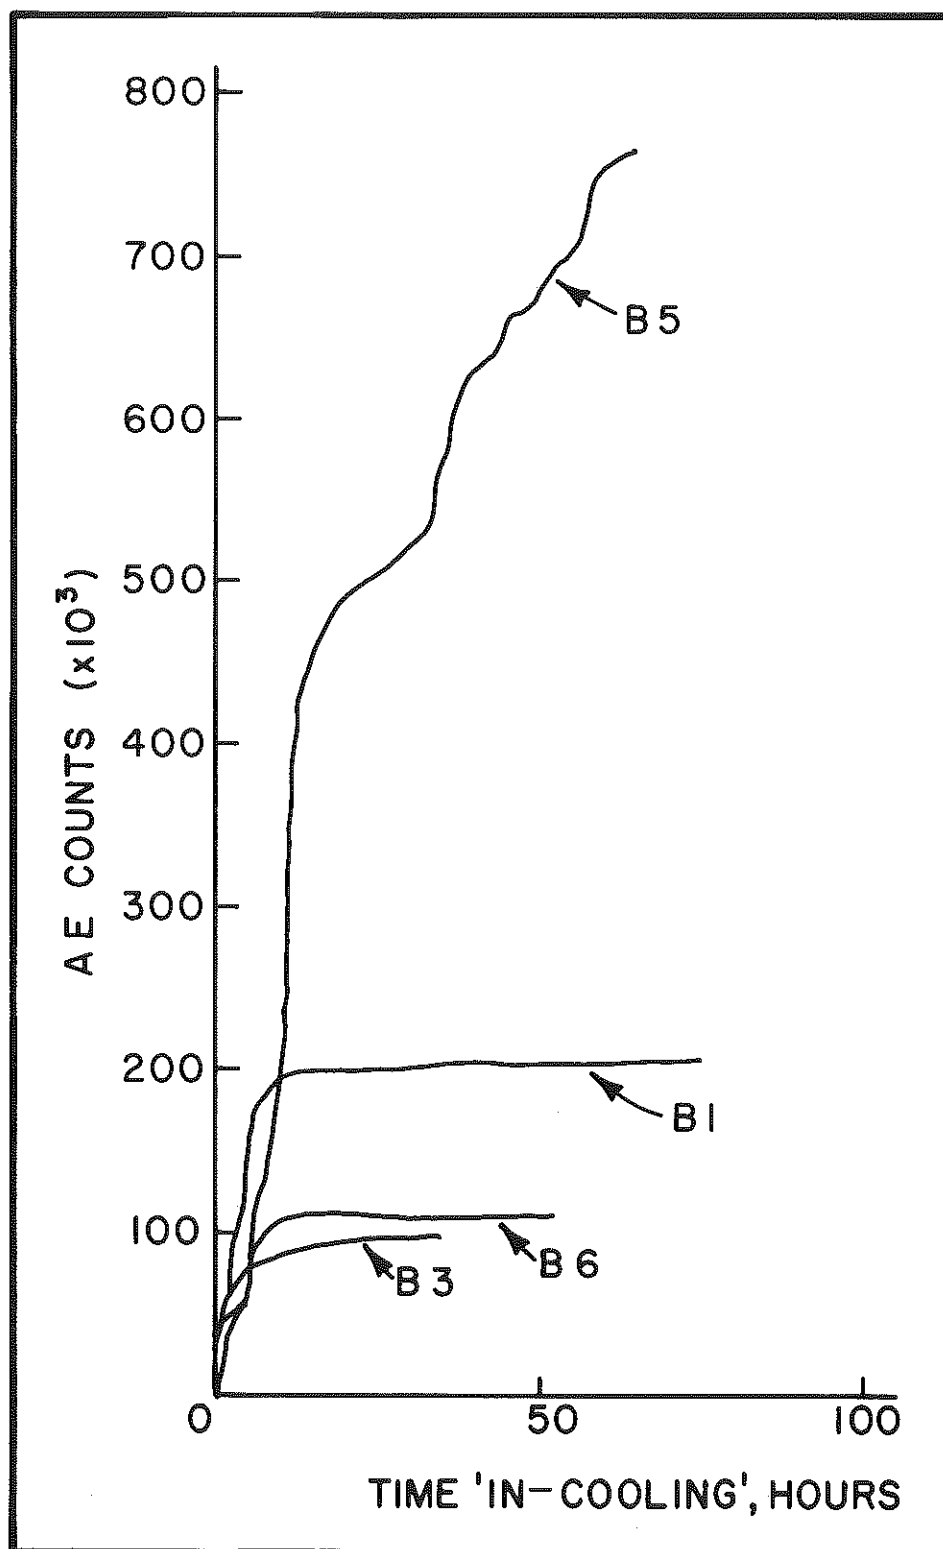
Figure 5. Total AE Counts versus Time for Butt-welded, ASTM A 514 Plates 'In-cooling'.

Equipment problems prevented a good correlation of total AE counts among the butt-welded A 514 tests. The behavior of AE count-vs-time after welding (in-cooling) for Tests 1, 3, 5, and 6 is shown in Figure 5. The cruciform specimens had much longer

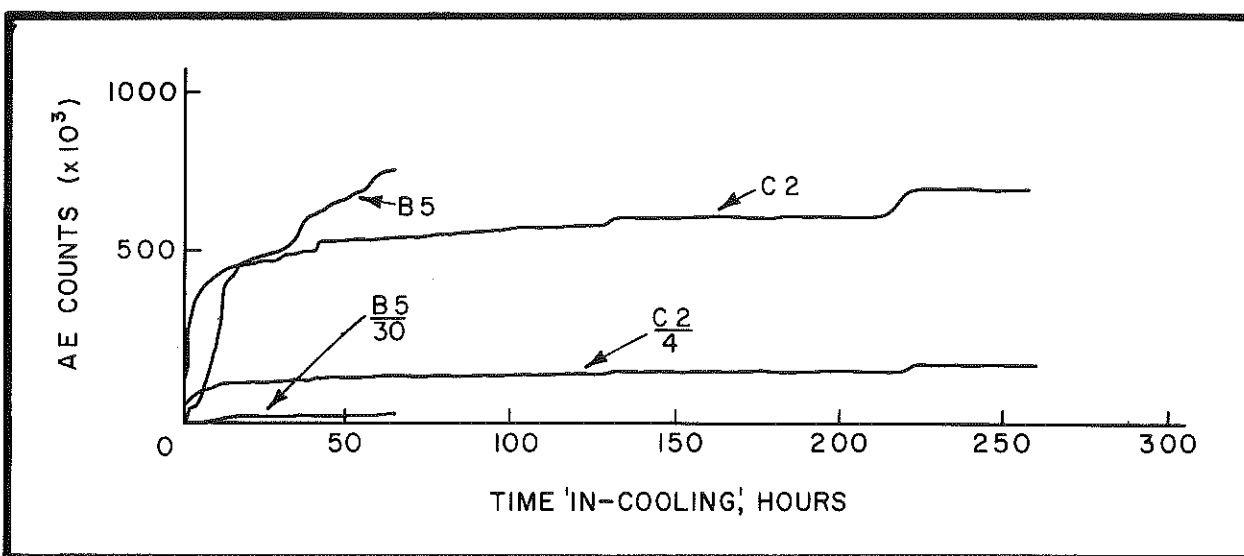
Figure 6. Total AE Count Behavior of ASTM A 514, Butt-welded and Cruciform Specimens on a per Electrode Basis.

periods of AE activity. In most cases, the cruciform specimens emitted larger amounts of acoustic emissions than the butt-welded plates. When considered on a per-electrode basis, which presumes AE activity due to solidification kinetics and plastic deformation can be compared based on the relative amounts of weld metal deposited (30 electrodes on the butt-welded plates, four electrodes on the cruciform specimens, and one electrode on the Lehigh specimens), as shown in Figure 6, this contrast is more readily evident.

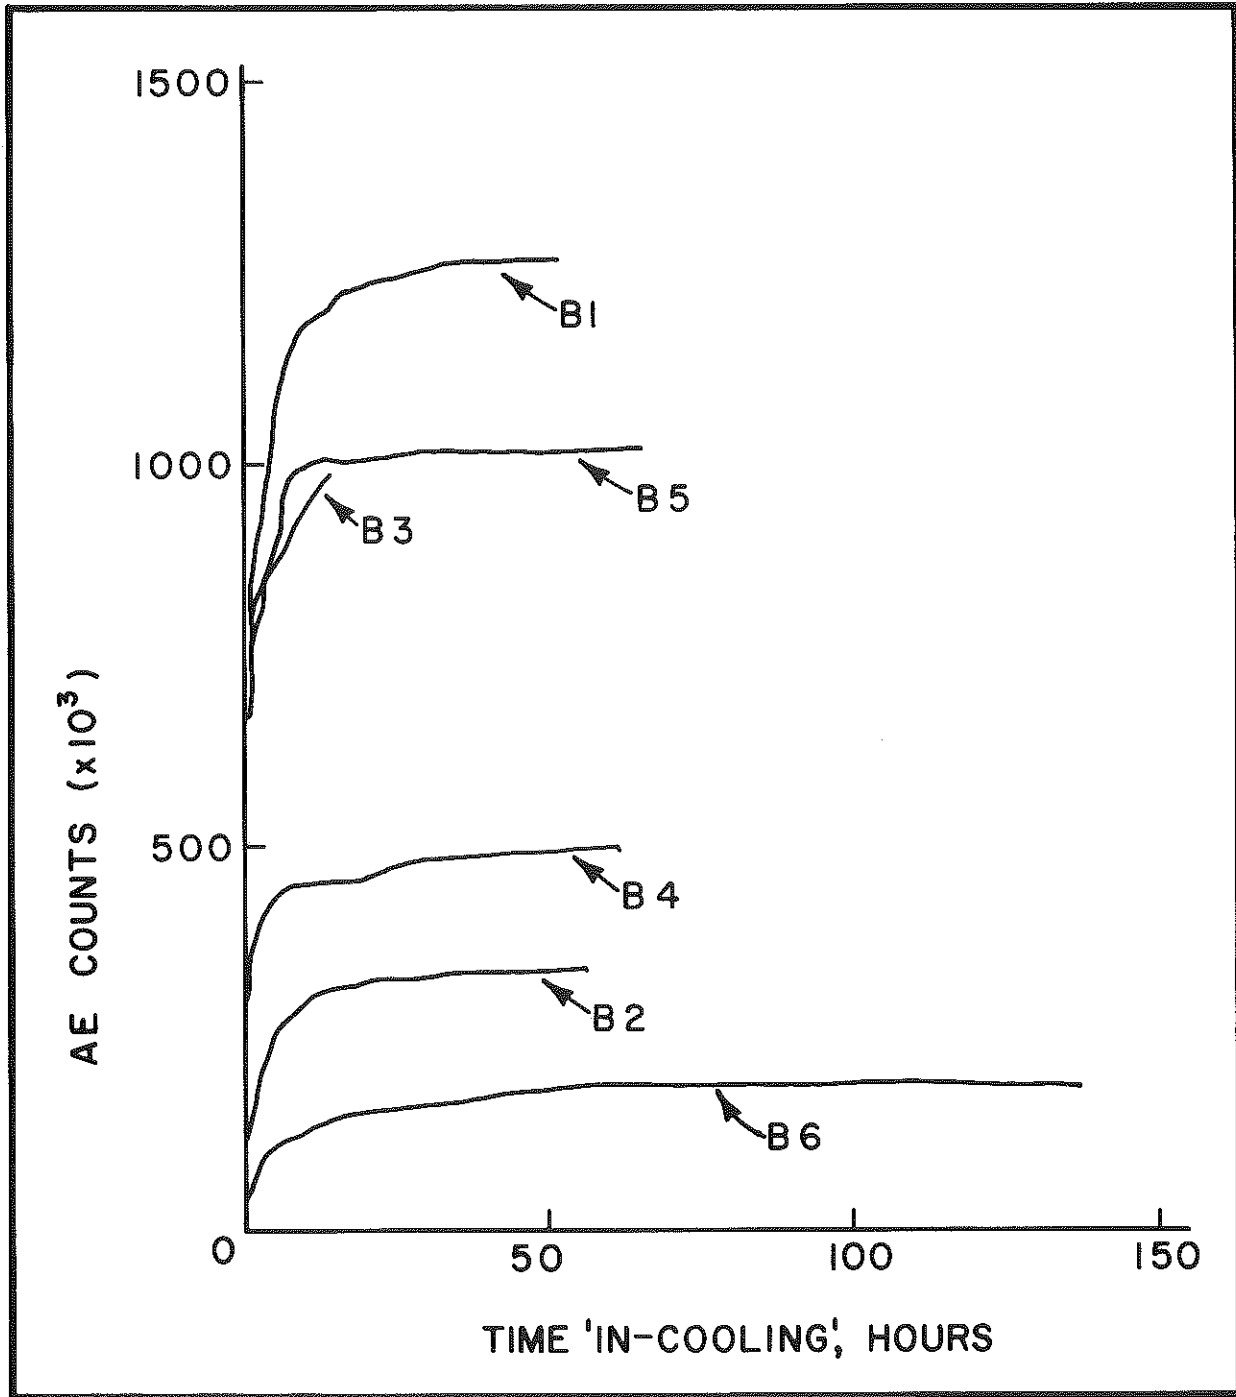
Figure 7. AE Total Counts vs Time for Butt-welded ASTM A 588 Plates 'In-cooling'.

Equipment problems also adversely affected the data for butt-welded A 588 specimens. However, the duration of AE activity for Tests 2, 3, 4, and 6 correspond closely. Figure 7 shows the behavior of AE counts-vs-time after welding (in-cooling) for the butt-welded A 588 specimens. Considering that Lehigh Test No. 1 fractured prior to AE monitoring, a good correlation exists between a high total AE activity and fracture. However, there is no direct correlation between the duration of AE activity and fracture. The Lehigh specimens had shorter periods of AE activity than the butt-welded specimens. The Lehigh specimens had significantly higher total AE counts per electrode deposited than the butt-welded A 588 plates as shown in Figure 8. The butt-welded A 588 plates had longer periods of AE activity than the A 514 butt weldments. Conversely, the restrained cruciform weldments had much longer periods of acoustic emission activity than the Lehigh specimens.

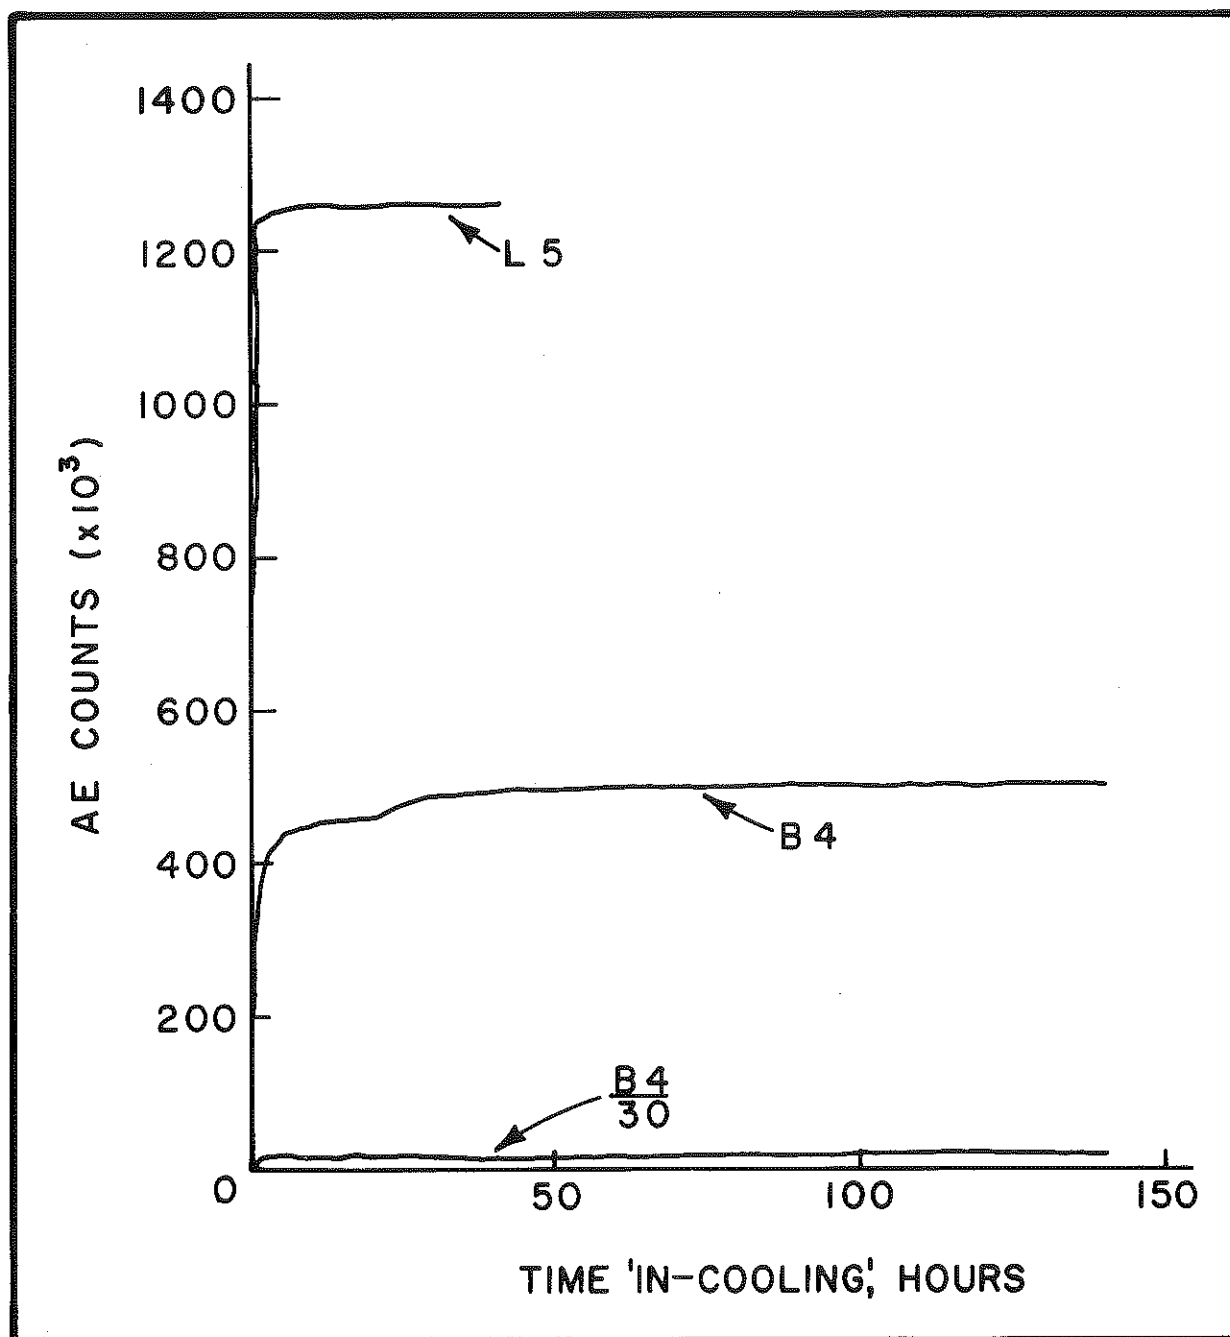
Figure 8. Total AE Count Behavior of ASTM A 588, Butt-welded and Lehigh Specimens on a per Electrode Basis.

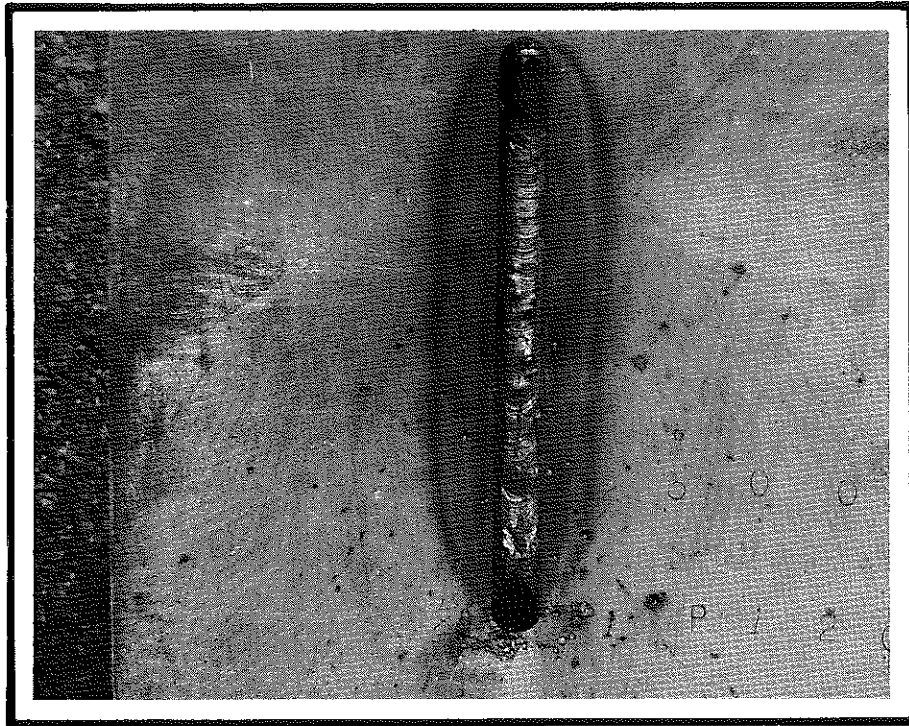
Figure 9. Fracture in Lehigh Specimen No. 1.

Cracking was a major source of acoustic emission in the restrained specimens. Fractured Lehigh specimens, which were monitored successfully, produced more AE activity than specimens which had little or no fractures. The increase in the total AE count with cracking is also apparent in the cruciform tests. As shown in Figures 9 and 10, the Lehigh specimens fractured by a ductile tear in the weld metal, due to the high tensile residual forces. The cruciform welds, as shown in Figure 11, fractured by crack growth from re-entrant notches created at faying faces of the steel plates. These cracks grew in low-energy paths on the third and fourth weld beads between columnar dendritic grains created by the weld solidification process.

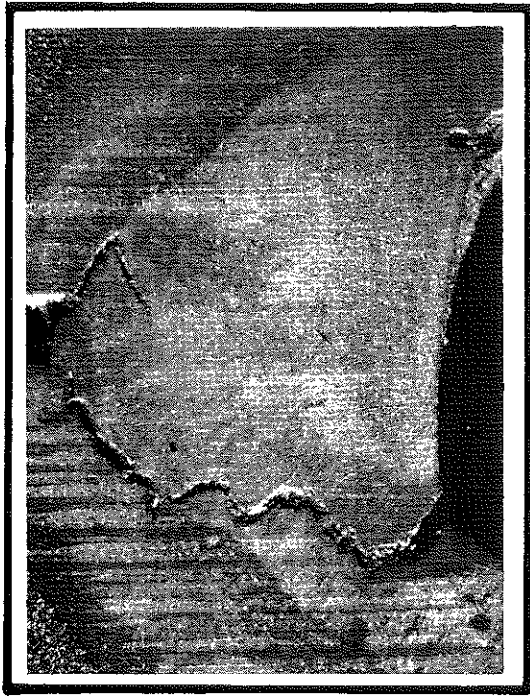
Figure 10. Cross-sectional View of Fracture in Lehigh Specimen No. 1.

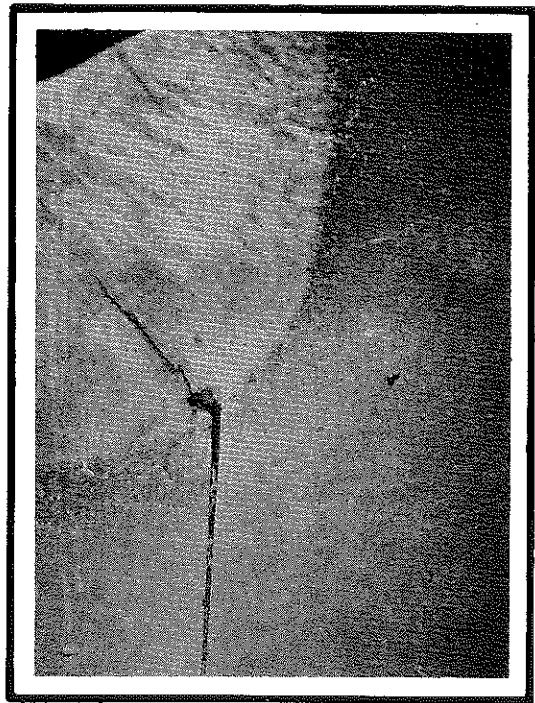
Figure 11. Cross-sectional View of Fracture in Cruciform Specimen No. 2.
